Rail Accident Report

Detrainment of passengers onto electrically live track near Peckham Rye station 7 November 2017

Report 16/2018
October 2018

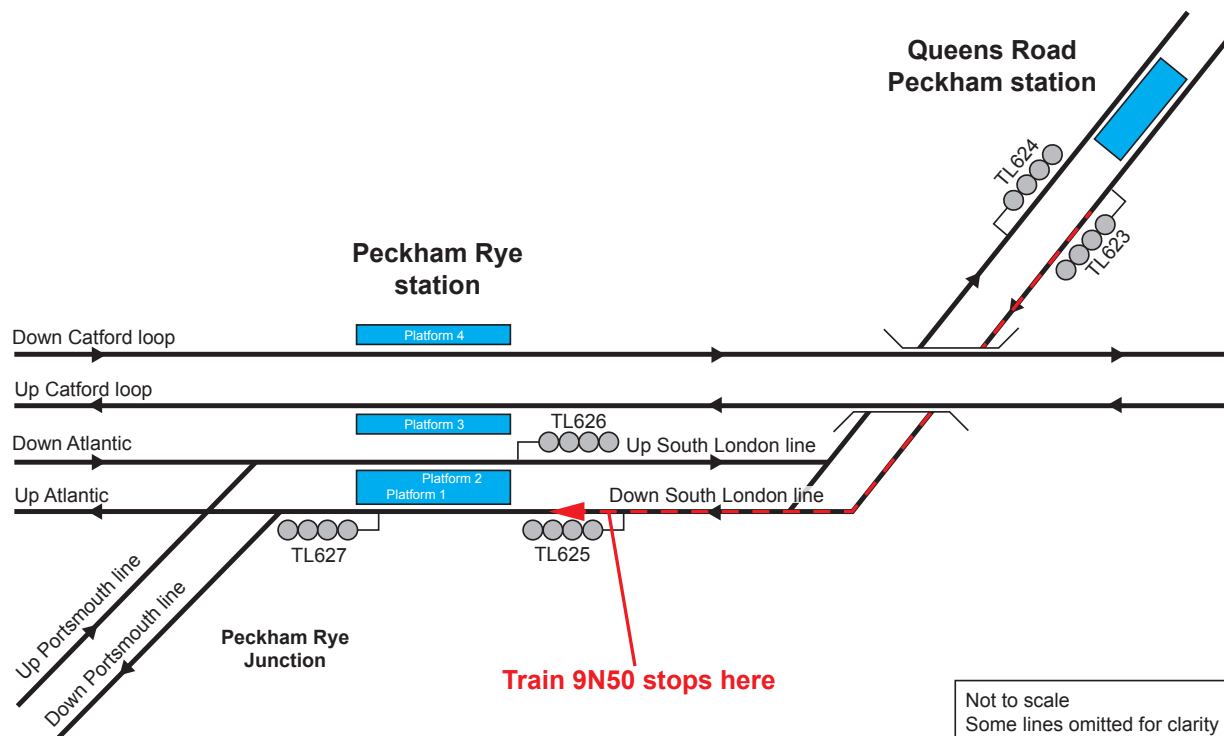
- 6 The train came to a stand on the Down South London line, approximately 30 metres away from the east end of platform one on the approach to Peckham Rye station. This part of the station consists of an island platform situated between the Up and Down South London lines (figures 2 and 3).

Figure 2: Track layout showing the location of the incident

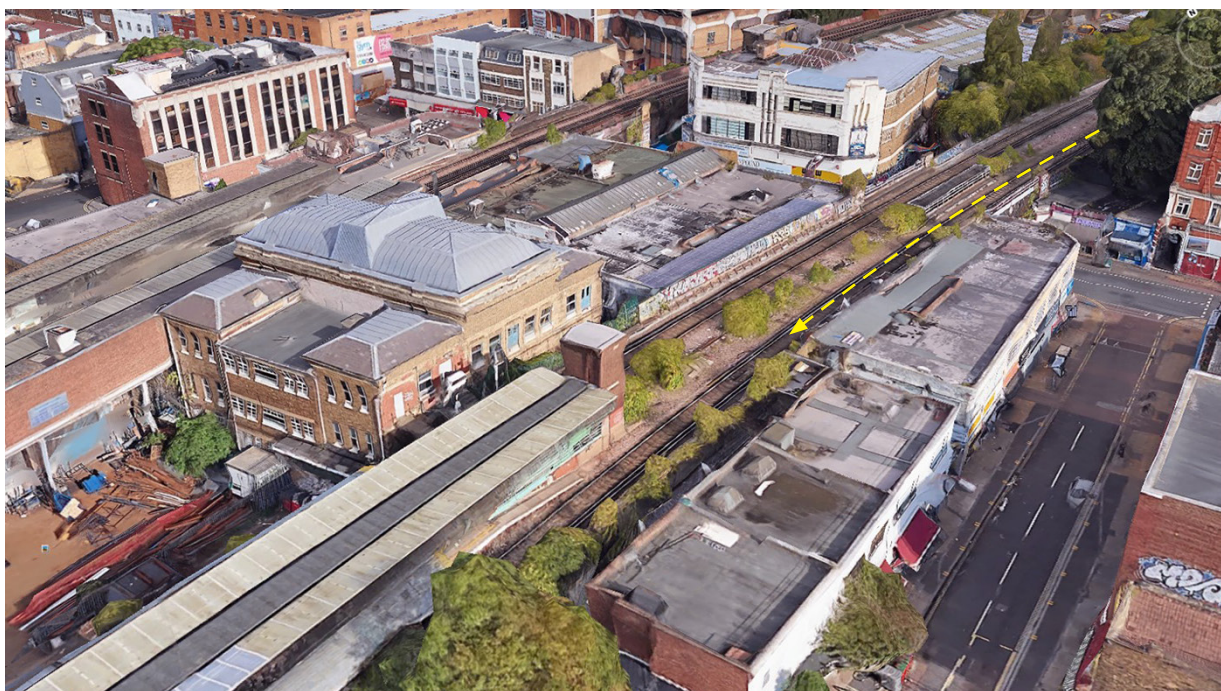
Figure 3: Peckham Rye station, with the South London line platforms bottom left (image courtesy of Network Rail)
